**Overall description:** Circuit from Lough Dam to Scarr summit via Kanturk - well define line

**Overall assessment:** Level of use is limited by parking availability. Not deteriorating rapidly

# Kanturk – Scarr (Section 1)

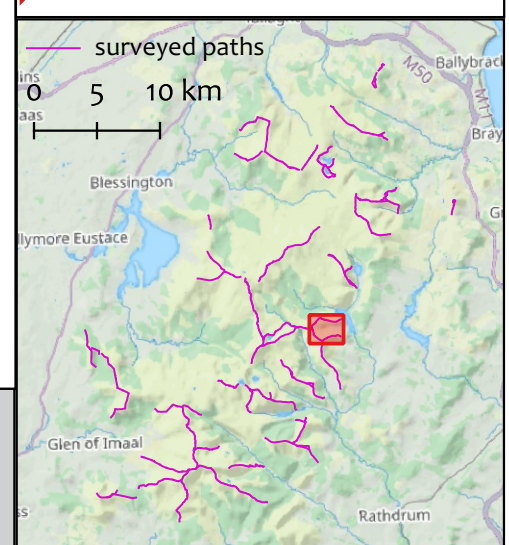
Section description: Start of path

**Site Assessment:**Easy access on agricultural track

| Work type | Estimated input | Work Summary |
|---|---|---|
| part_repair | 10 days labour | Replace 30m steps; finish the bypass route or add 5 steps; |
