Survey date: Jul 21, 2021

Length: 6899m

Sections: 12

## Lobawn (Section 1)

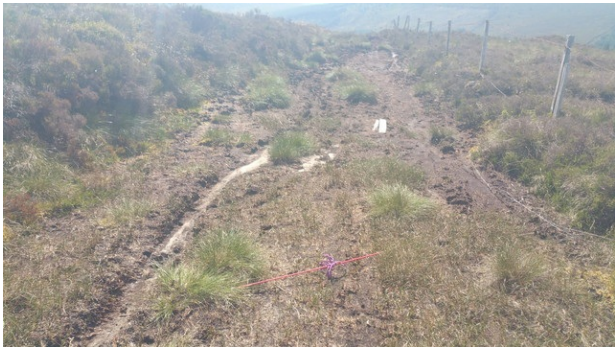
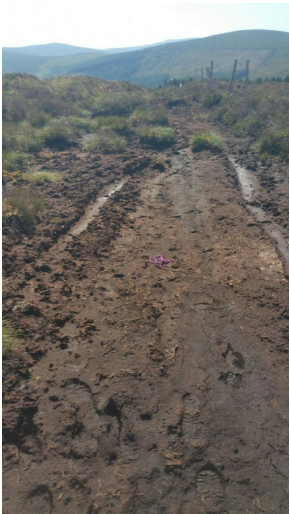
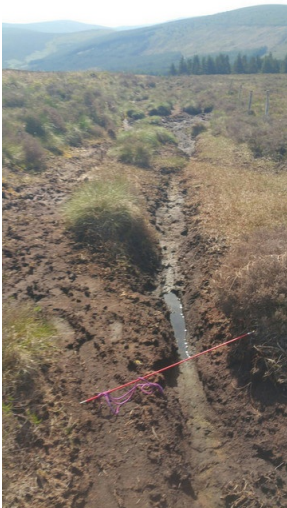
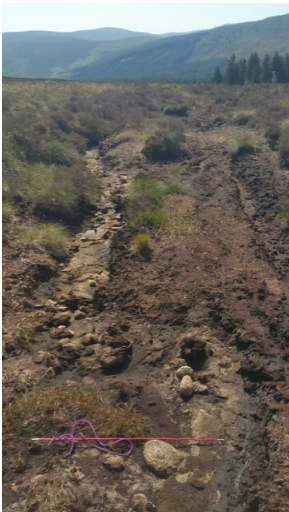
| | Minimum | Maximum | Typical |
|---|---|---|---|
| Eroded depth (m) | 0.3 | 0.5 | 0.8 |

**Site Assessment:**Machine access good: 4 days  
 low pressure excavator hire

| Work type | Estimated input | Work Summary |
|---|---|---|
| part_repair | 40 days labour | Scrape peat and reprofile edge 400m - difficult to do by hand |

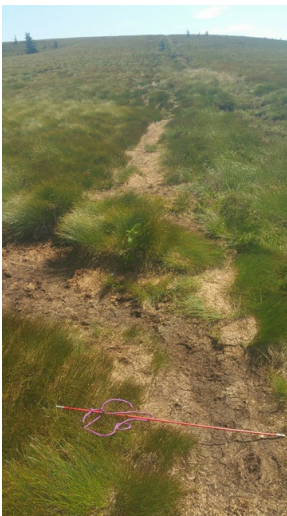
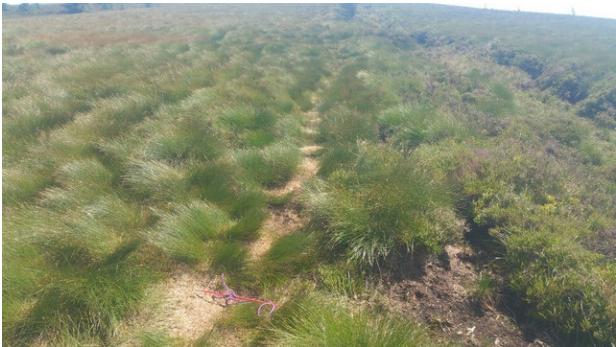
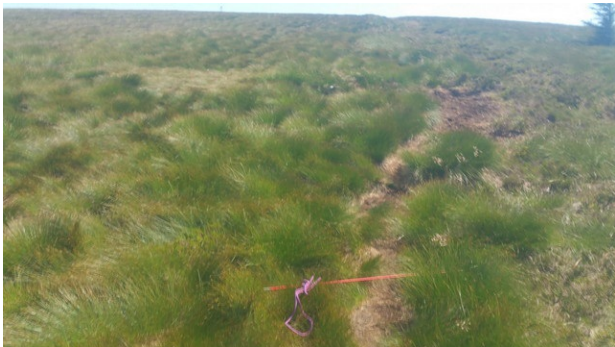
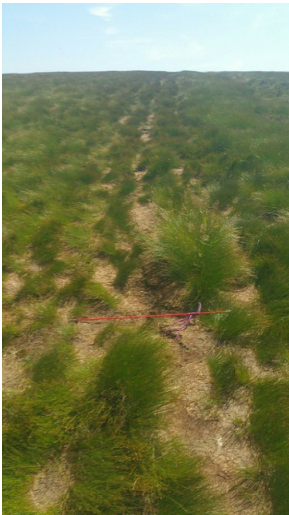
**Site Assessment:**Degraded blanket bog.

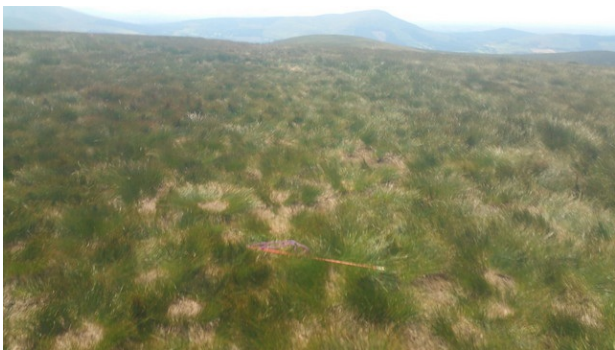
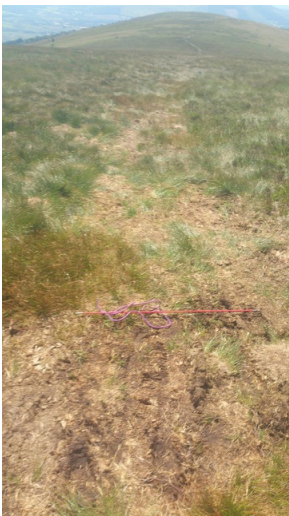
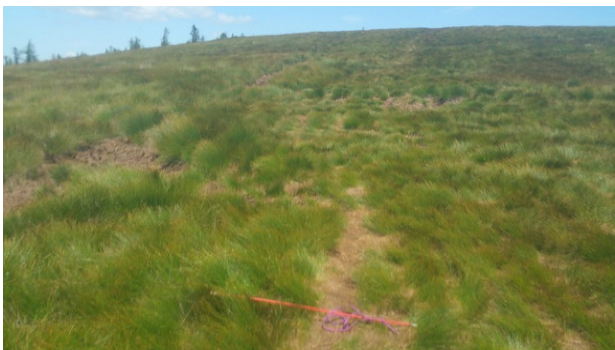
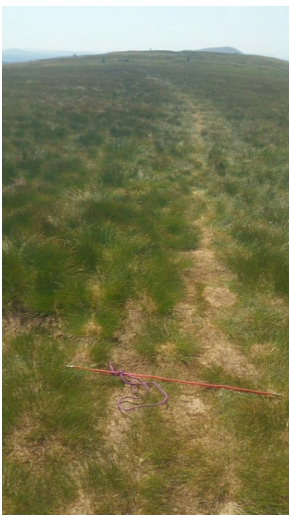
| Work type | Estimated input | Work Summary |
|---|---|---|
| none | | Deep peat for most of section |

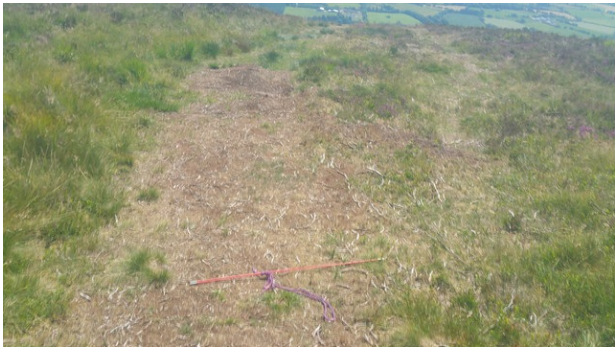
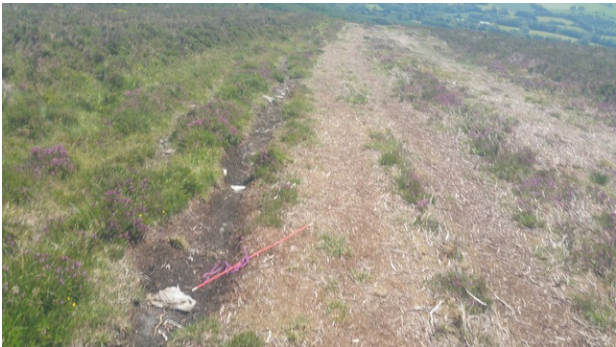
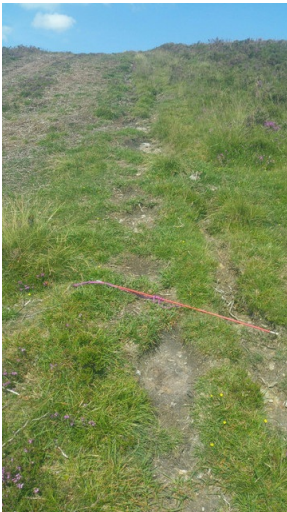
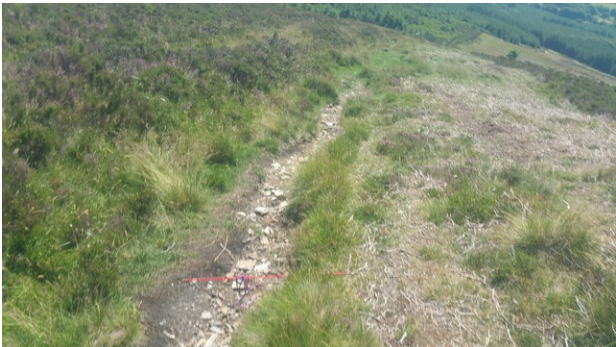
**Site Assessment:**Upper 200m approx 20%. Quad damage

| early_intervention | 5 days labour | 5 water bars on steep ground if quad bikes can be prevented from using this route |
