Maulin loop

Maulin loop (Section 1)Start: O 19133 14101 (± 12m)End: O 19006 13876 (± 10m)Section description: Section starts at junction and is a constructed path leading up through forest. There is a short-cut braid part way up.

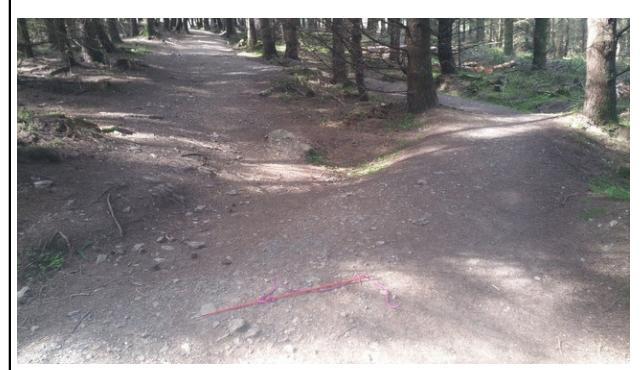
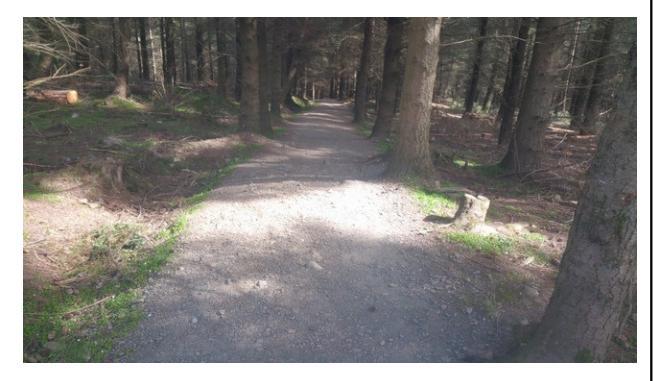
Substrate		Peat Depth (cm)		Availability of Materials: Recently cut logs
mineral_soil		0		nearby which may be suitable
	Minimum	Maximum	Typical	Site Assessment: Easy access on forest road
Trampled width (m)	1.8	2	4	
Bare width (m)	1.8	2	2.5	
Eroded depth (m)	0	0	0.1

Work type	Estimated input	Work Summary
minor_repair	15 days labour	Logs used as water bars and steps are rotten and need replacing.

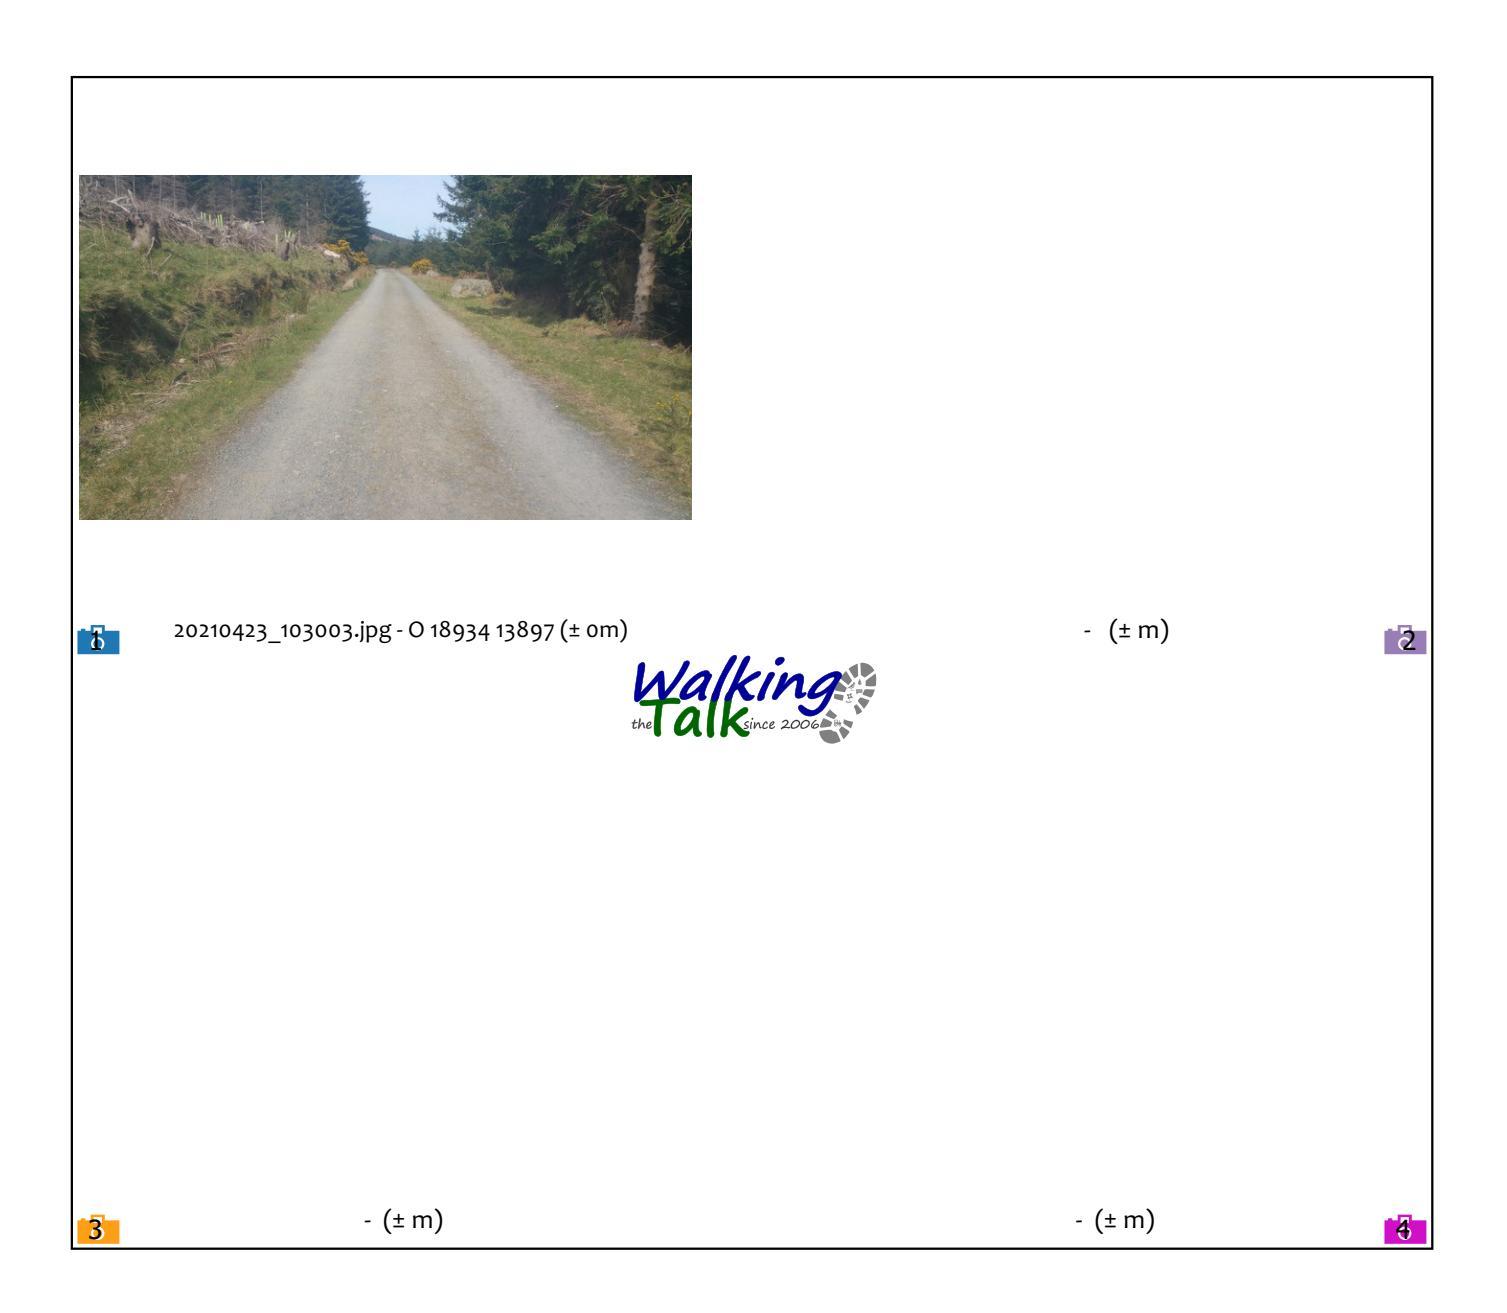
Maulin loop (Section 2)Start: 0 19Section description: Forest road - used by vehicles so not surveyed

Work type	Estimated input	Work Summary
none

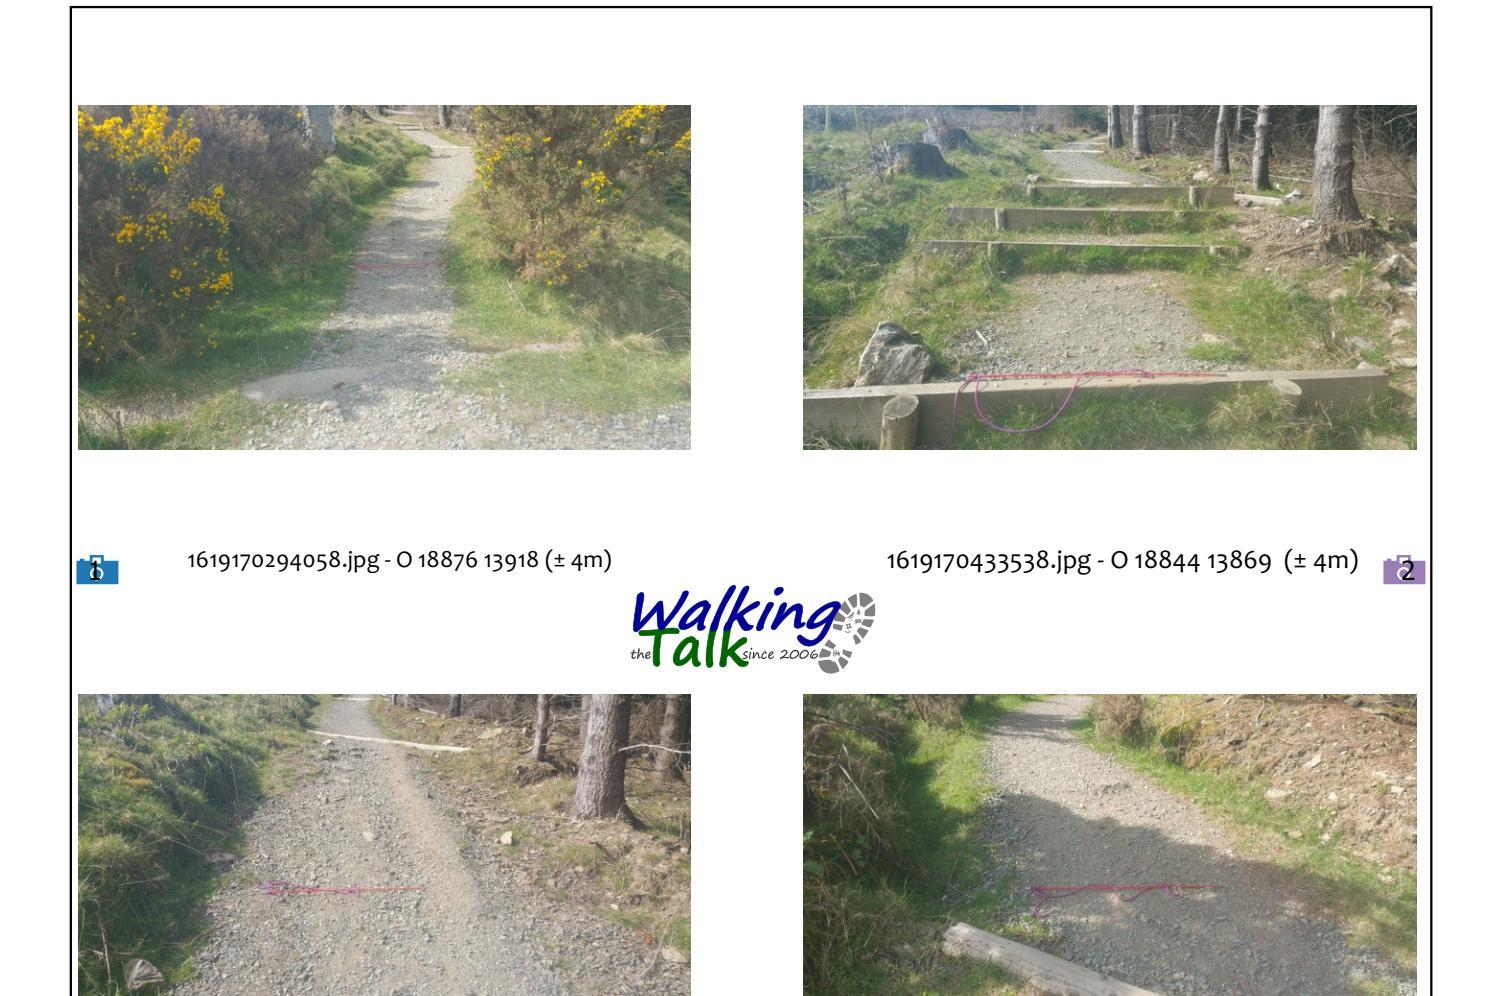
Maulin loop (Section 3)Start: O 18877 13914 (± 8m)End: O 18805 13810 (±Section description: Section starts at junction with forest road and runs directly uphill. Anchor bars recorded are logs

Work type	Estimated input	Work Summary
none		No work currently required

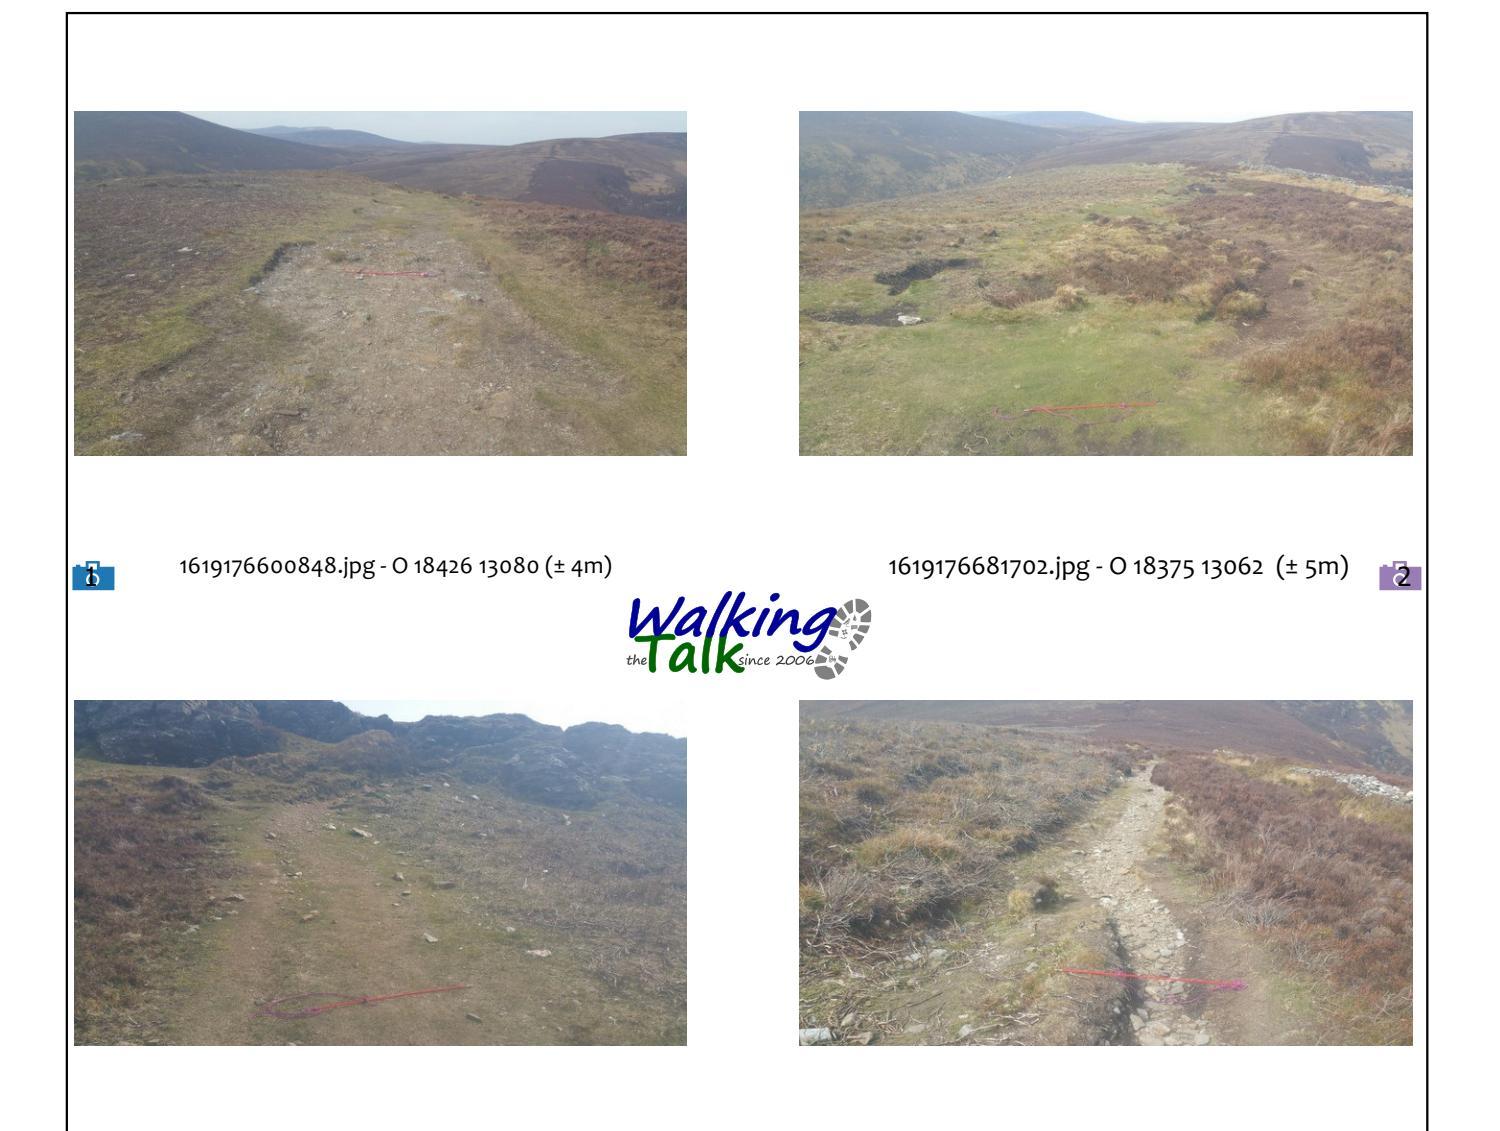
Section description: Section starts at the summit of Maulin and follows the ridge along towards Tonduff. There are small areas of peat >40cm deep but aggregate is at the surface for much of the section. Provides an alternative loop avoiding steep section on north side of Maulin.

Substrate		Peat Depth (cm)		Availability of Materials: No block stone - would
peat		40		need to be flown in 50 bags of stone needed
	Minimum	Maximum	Typical	Site Assessment: Limited access for machinery
Trampled width (m)	0.5	1.5	6	
Bare width (m)	0	0.8	2	
Eroded depth (m)	0	0.4	0.8

Work type	Estimated input	Work Summary
major_repair	40 days labour	Could be fully upgraded or partially upgraded with the installation of waterbars and anchors to reduce aggregate movement
