Survey date: Apr 23, 2021

**Overall description:** Signposted route from Djouce across deep peat on the col and steep gradients

**Overall assessment:** Col is badly eroded. There is extensive deep peat and steep gradients. Unsustainable line

# War hill (Section 1) Section description: Summit

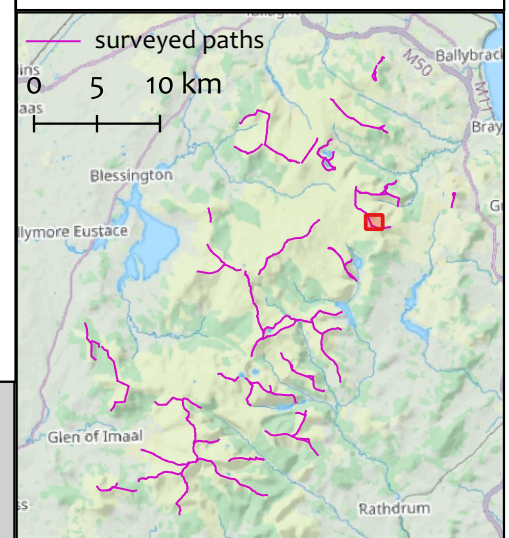
Site Assessment:Open slope impossible to manage access in deep peat

| none | | Block gullies as part of peatland restoration |
