Survey date: Apr 23, 2021

Overall description: Surveyed path extends from the water gates to the summit of Maulin.

Wicklow Way to Maulin (Section 2)

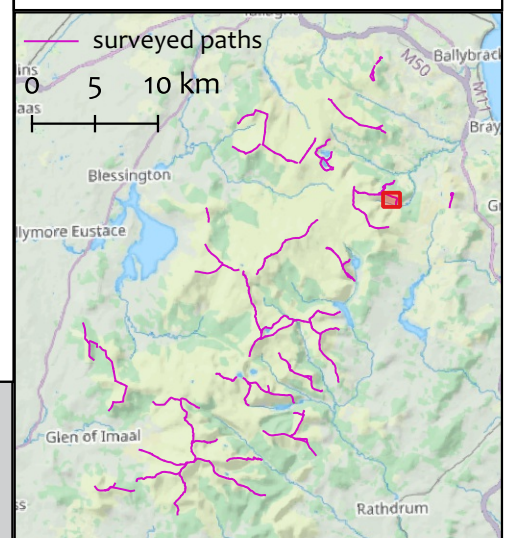
Length (m)	Max gradient (%)	Min gradient (%)	Crossfall (%)
279	28	10	0

Substrate	Peat Depth (cm)
mineral_soil	0

Minimum	Maximum	Typical
Trampled width (m)	2.5	3	5
Bare width (m)	0.8	1.5	3
Eroded depth (m)	0	0	0

Availability of Materials: Good blockers available

Work type	Estimated input	Work Summary
part_repair	20 days labour	Blocking and landscaping or fully replace the pitching (300 days labour); trees and gorse would be effective blockers; Some pitching could be replaced with aggregate on lower gradient to stop people going off path

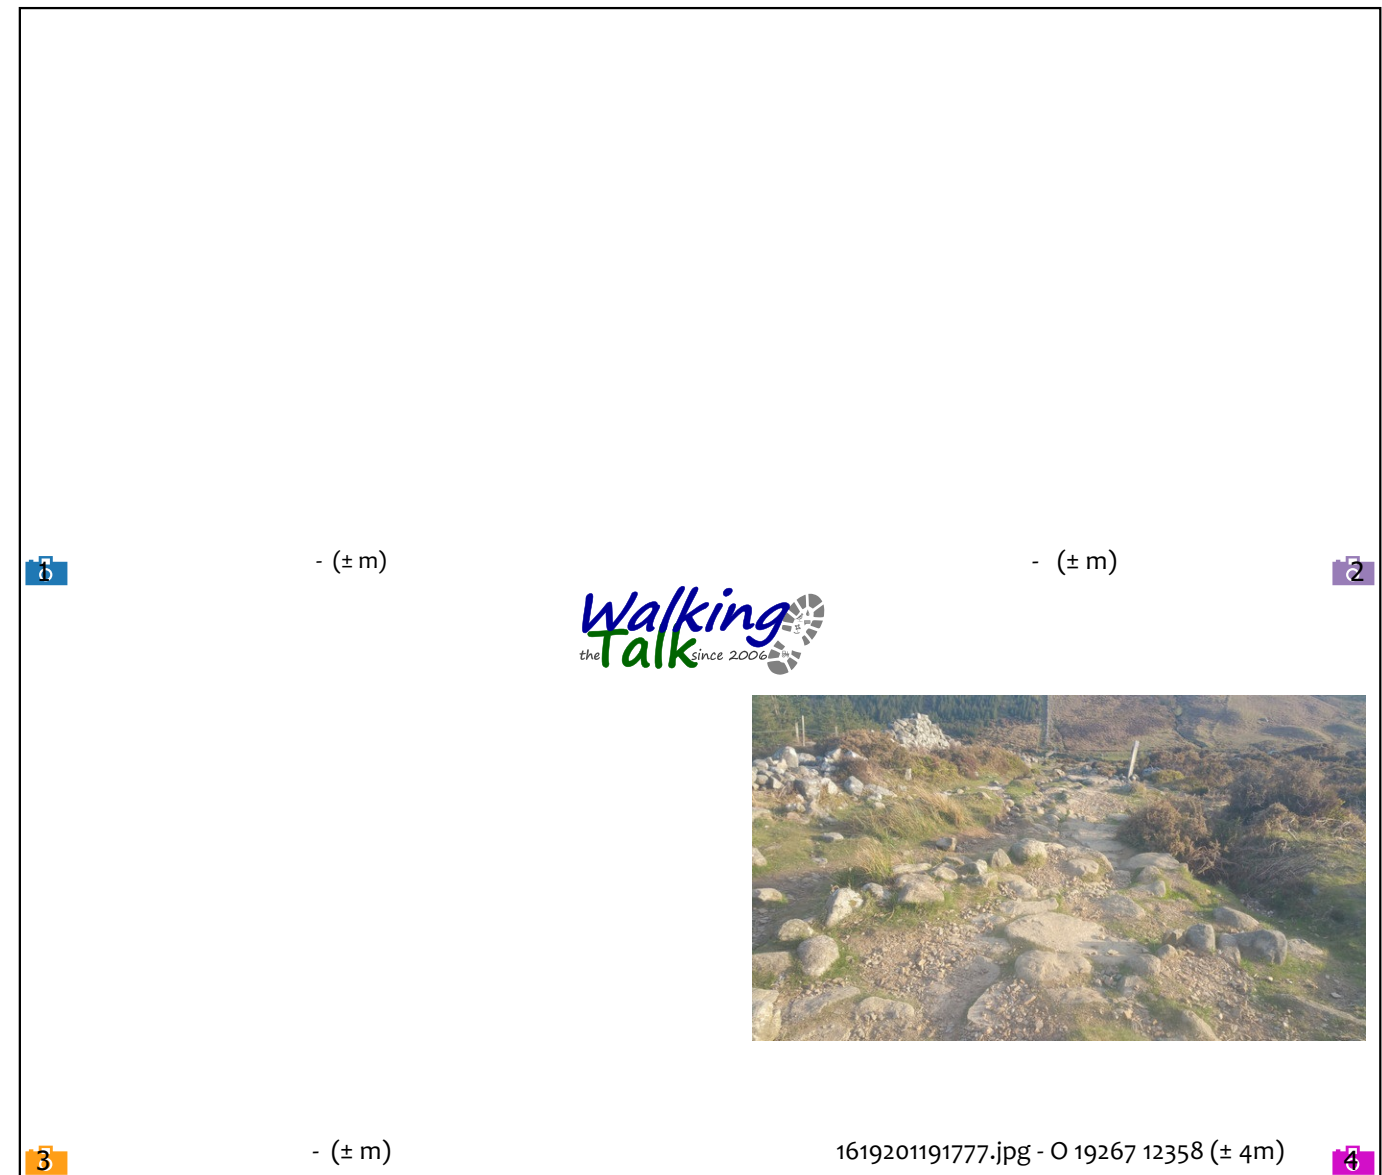
Section description: Leave wicklow way

Length (m)	Max gradient (%)	Min gradient (%)	Crossfall (%)
200	15	10	0

Work type	Estimated input	Work Summary
minor_repair	10 days labour	Anchor bars and 3 water bars; repair eroded surface
