Djouce

Djouce (Section 1) Section description: Summit

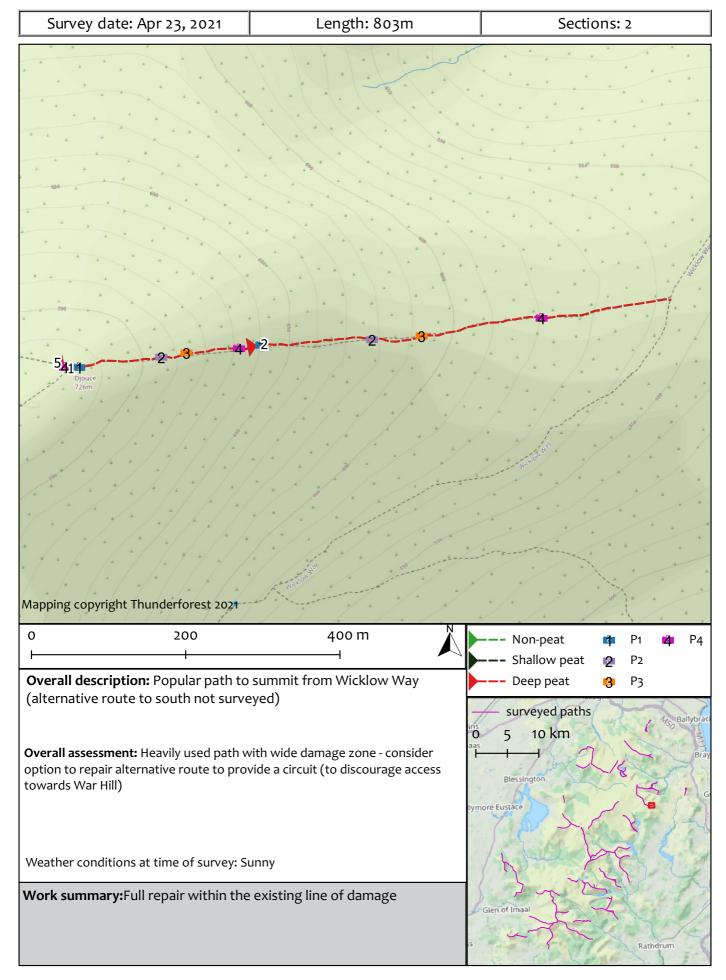
Length (m)	Max gradient (%)	Min gradient (%)	Crossfall (%)
258	32	22	0

Substrate	Peat Depth (cm)
peat	20

Minimum	Maximum	Typical
Trampled width (m)	20	20	25
Bare width (m)	6	8	12
Eroded depth (m)	0.1	0.1	0.3

Work type	Estimated input	Work Summary
major_repair	130 days labour	Zig zag pitch and aggregate within damage zone: 220m aggregate 15 water bars and anchors 20m pitch consider landscaping with jute net
