Lugnaquilla to Ballineddan

Lugnaquilla to Ballineddan (Section 1)
 Start: T 02573 91540 (± 0m)
 End: (± m)

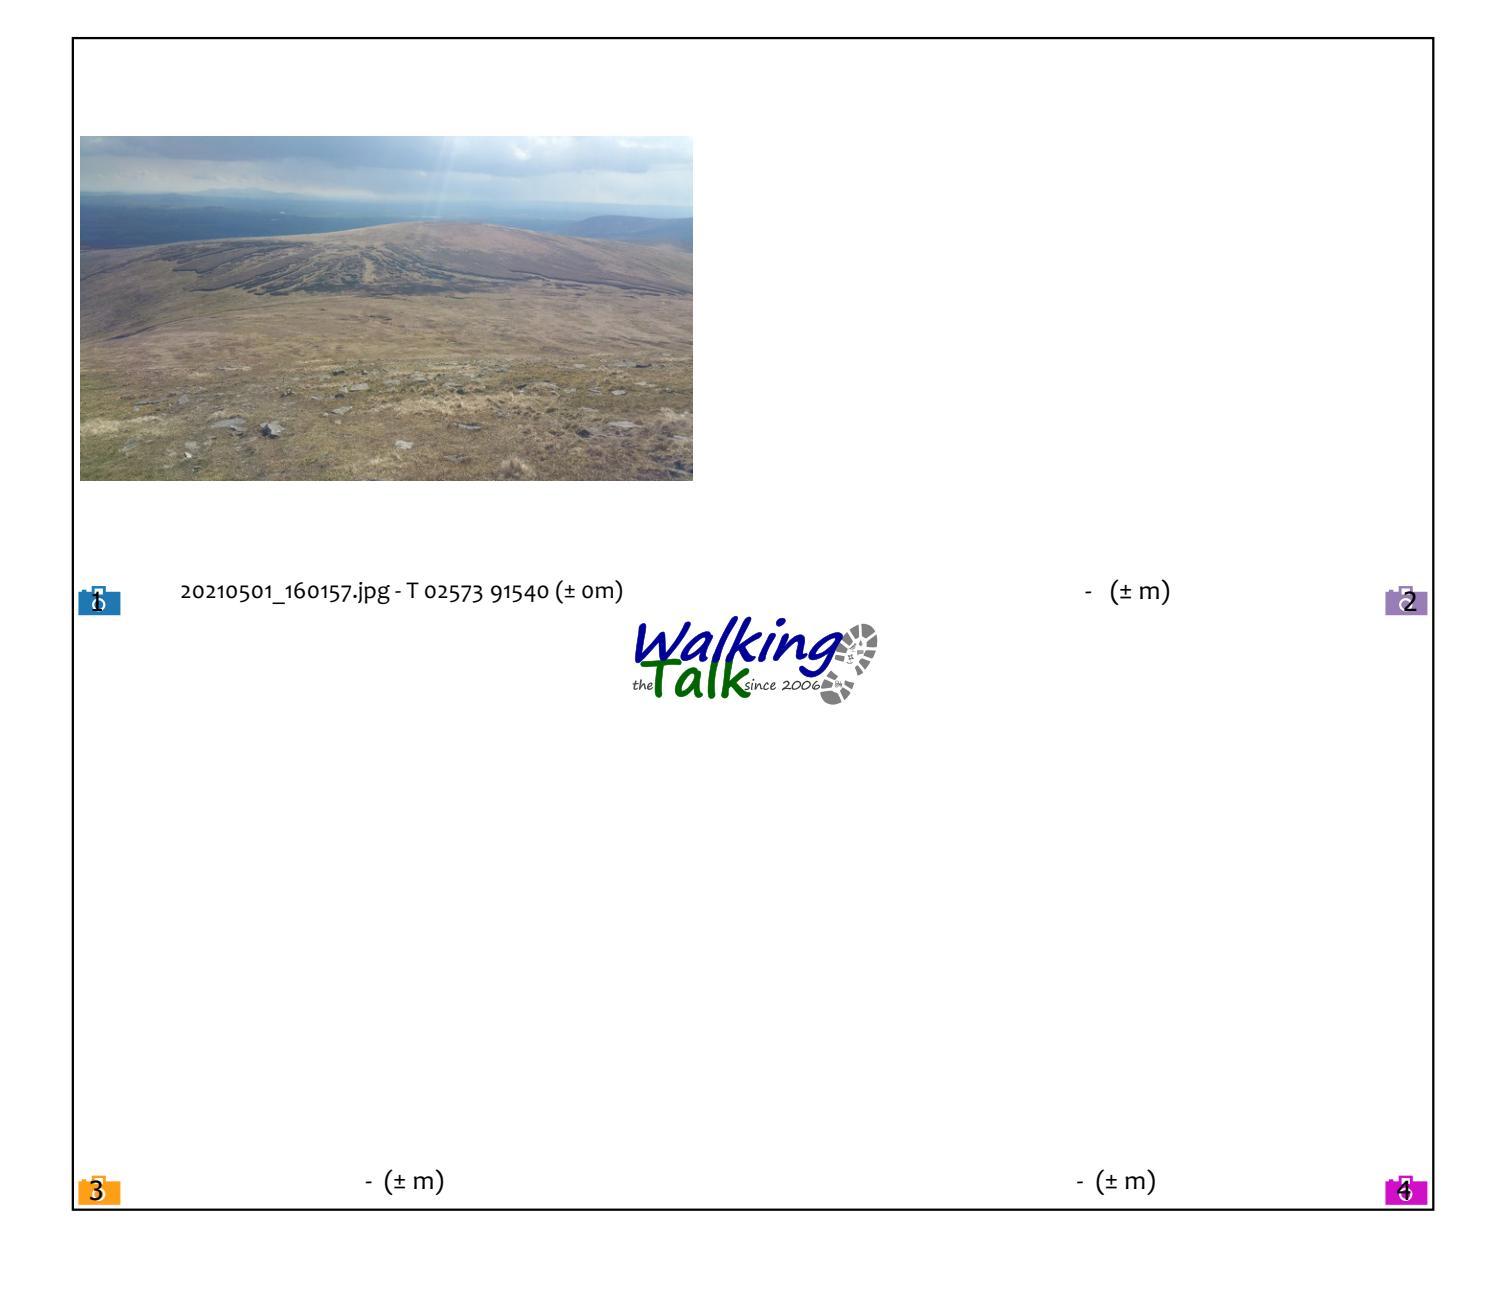
Lugnaquilla to Ballineddan (Section 2)
 Start: T 02573 91540 (± 0m)
 End: (± m)

Section description:
 Section starts near the chage of slope. It crosses the col and ends at the junction with the Lybagh

path. This route is used by quads and scrambler bikes with multiple braids having been developed across the col.

Substrate		Peat Depth (cm)		Availability of Materials: None at the surface
Peat		100		
				Site Assessment: Remote site with difficult
	Minimum	Maximum	Typical	access across the blanket bog
Trampled width (m)	10	20	30	
Bare width (m)	2	2.5	10	
Eroded depth (m)	0.1	0.3	1

Work type	Estimated input	Work Summary
none		No work to define a path is practical due to the level of quad / scrambler damage. If vehicles were prevented form accessing the route it might be possible to define a line across the deep peat (and restore damage) - it would need to be floated.

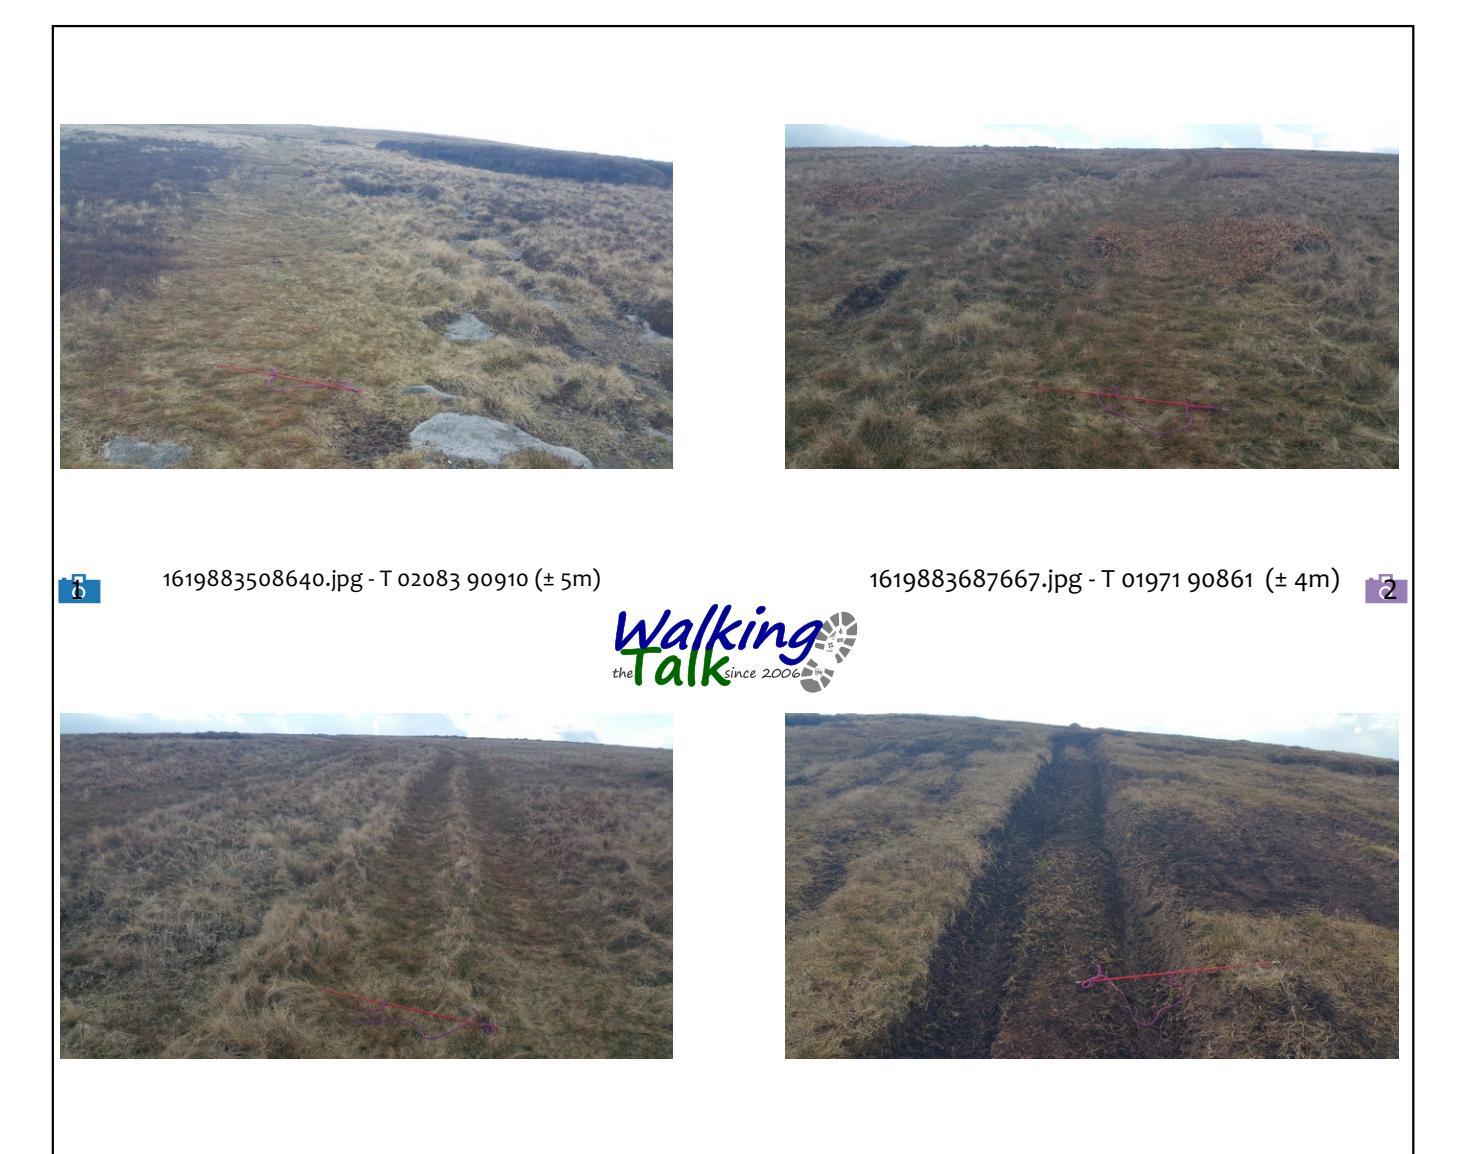
Lugnaquilla to Ballineddan (Section 3)Start: T 02085 90912 (± 4m)End: T 01759 90817 (± 4m)Section description:Section starts at junction with Lybagh path and runs to the summit of Slievemaan. It is essentially a quad bike track.

Substrate		Peat Depth (cm)		Availability of Materials: None at surface
peat		100		
				Site Assessment:Clearly it is accessible by quad
	Minimum	Maximum	Typical	bike at present
Trampled width (m)	6	7	15	
Bare width (m)	0	3	7	
Eroded depth (m)	0.2	0.3	0.5

Work type	Estimated input	Work Summary
none		Stop of-road vehicles using the route before any further consideration. Deep peat makes any proposals difficult to justify

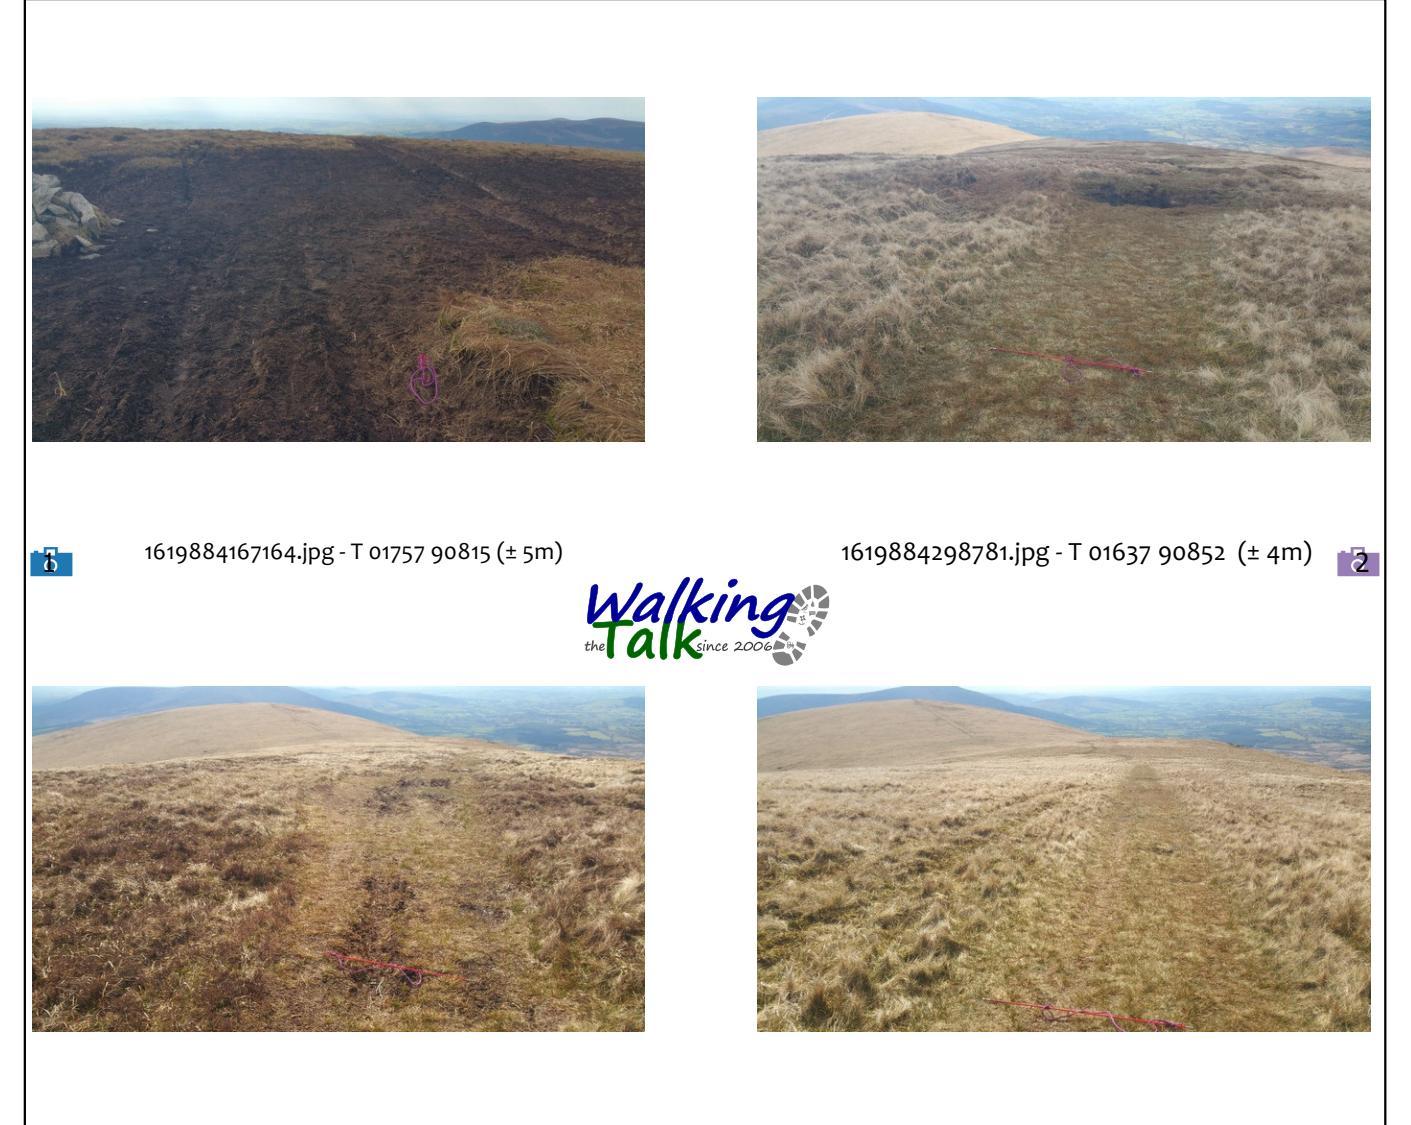
Lugnaquilla to Ballineddan (Section 4) Start: T 01759 90817 (± 9m) End: T 00760 90996 (± 4m)

Section description: Section starts at the summit of Slievemaan and runs down to the break of slope before the col at Ballineddan. Damage is worst around the summit with bare peat

Substrate		Peat Depth (cm)		Availability of Materials: None at surface
peat		40		
				Site Assessment: Clearly it is accessible by quad
	Minimum	Maximum	Typical	bike at present
Trampled width (m)	1.5	2	6	
Bare width (m)	0	0	2	
Eroded depth (m)	0	0	0.5

Work type	Estimated input	Work Summary
none		No work viable with off road vehicle use.

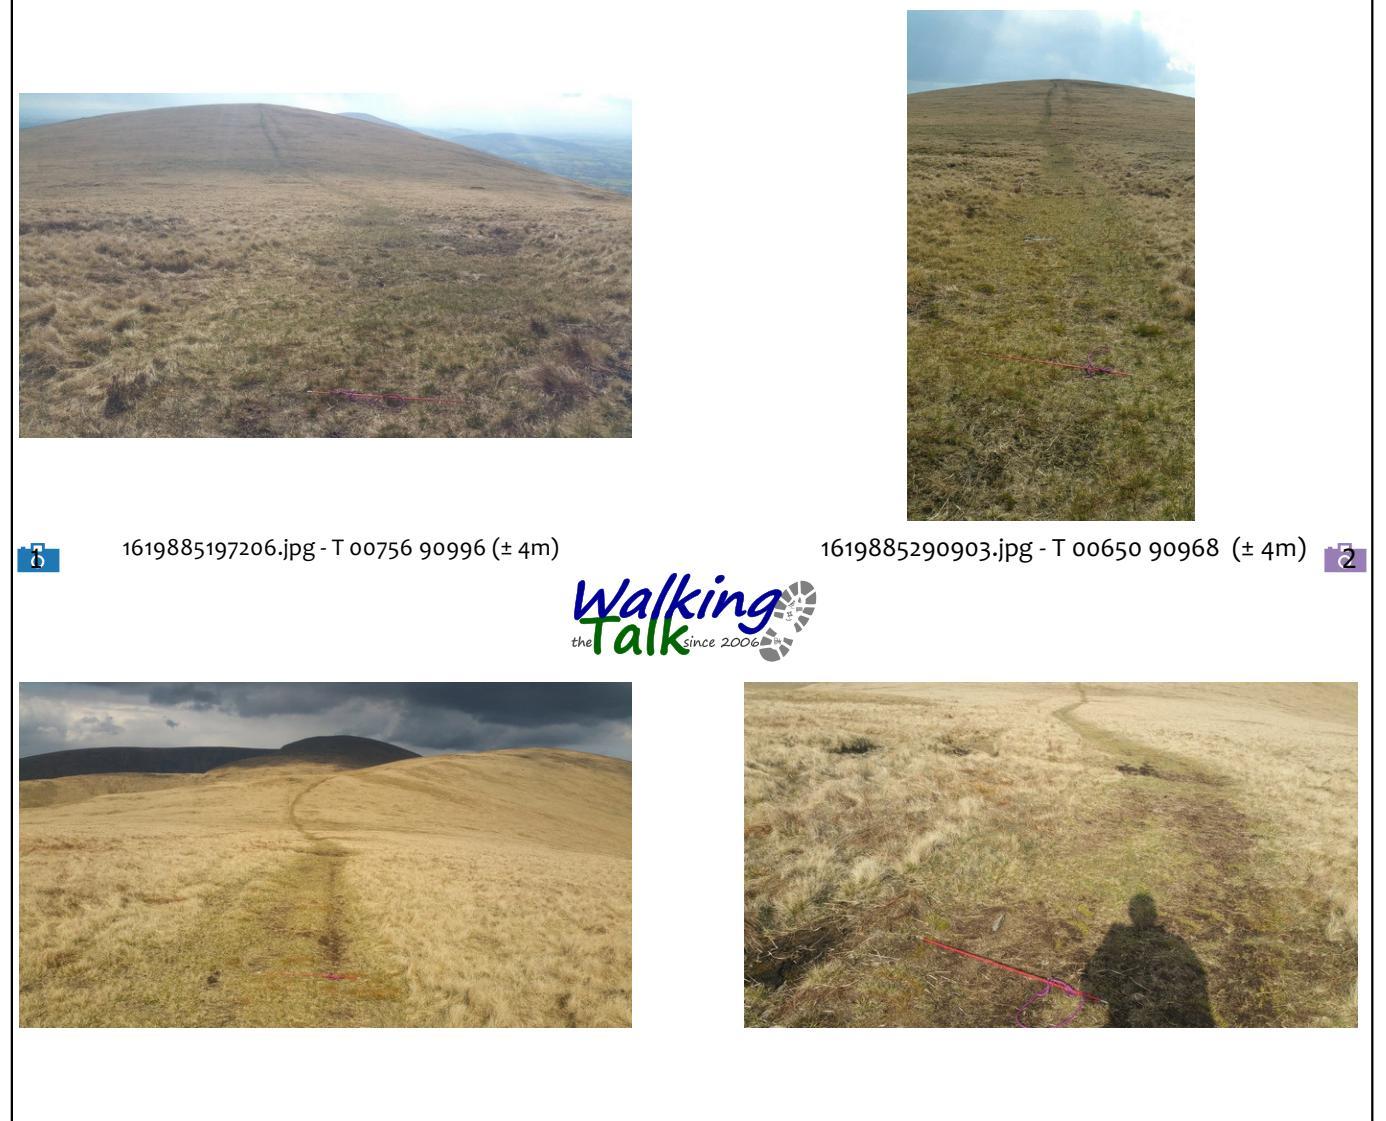
Lugnaquilla to Ballineddan (Section 5) Start: T 00760 90997 (± 4m) End: T 00256 90784 (± 4m)

Section description: Section starts at boulders to west of path on a chage of gradient and runs to the summit of Ballineddan.

Substrate		Peat Depth (cm)		Availability of Materials: None at the surface
peat		20		
				Site Assessment:Clearly it is accessible by quad
	Minimum	Maximum	Typical	bike at present
Trampled width (m)	1.2	1.5	4	
Bare width (m)	0	0	0	
Eroded depth (m)	0	0	0.1

Work type	Estimated input	Work Summary
none		No work is required and would not be advisable while the route is used by off road vehicles

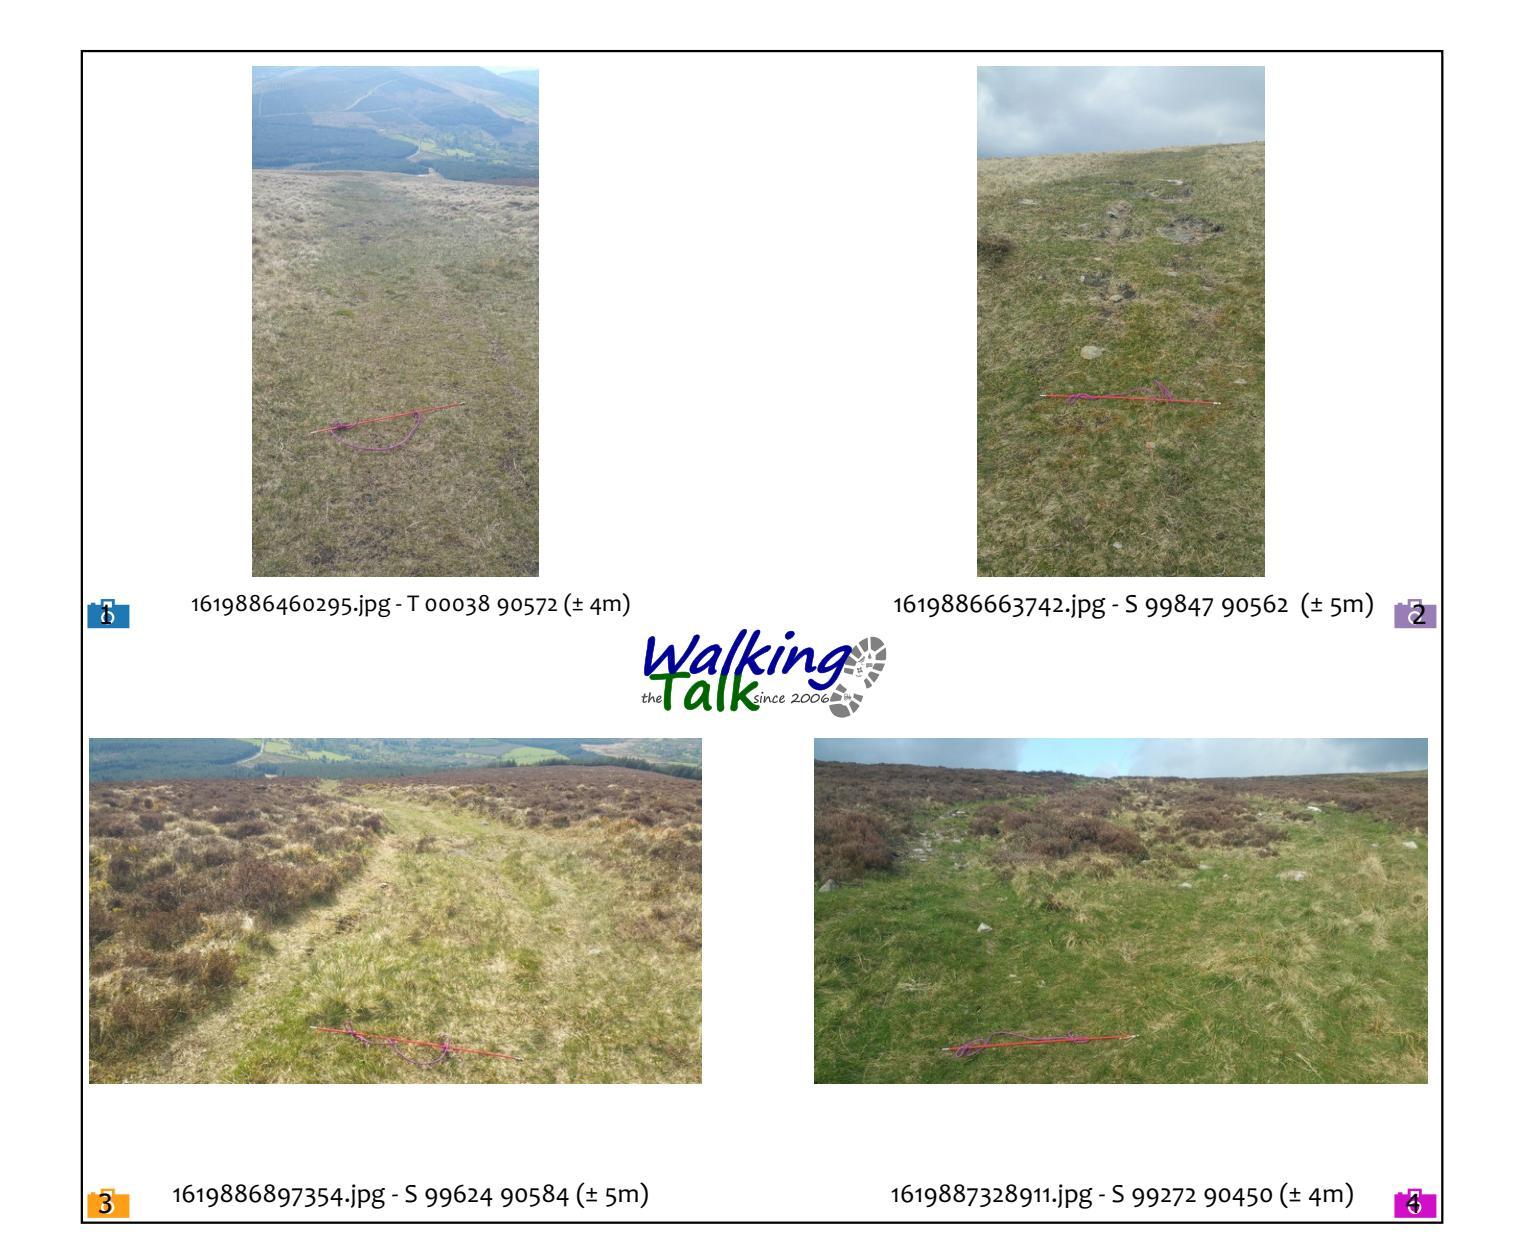
Lugnaquilla to Ballineddan (Section 6)Start: T 00256 90784 (± 9m)End: S 99209 90427 (± 4m)Section description: This section starts at the summit of Ballineddan and follows the fall line down to a right-angled corner.

Substrate		Peat Depth ((cm)	Availability of Materials: Some stone at surface
peat		30		
				Site Assessment: Used by off road vehicles
	Minimum	Maximum	Typical	
Trampled width (m)	2.5	1.8	8	
Bare width (m)	0	0	4	
Eroded depth (m)	0	0.1	0.2

Work type	Estimated input	Work Summary
none		Remove off road vehicle access before considering any other intervention. Drainage could be istalled to deflect surface water off the grassy line

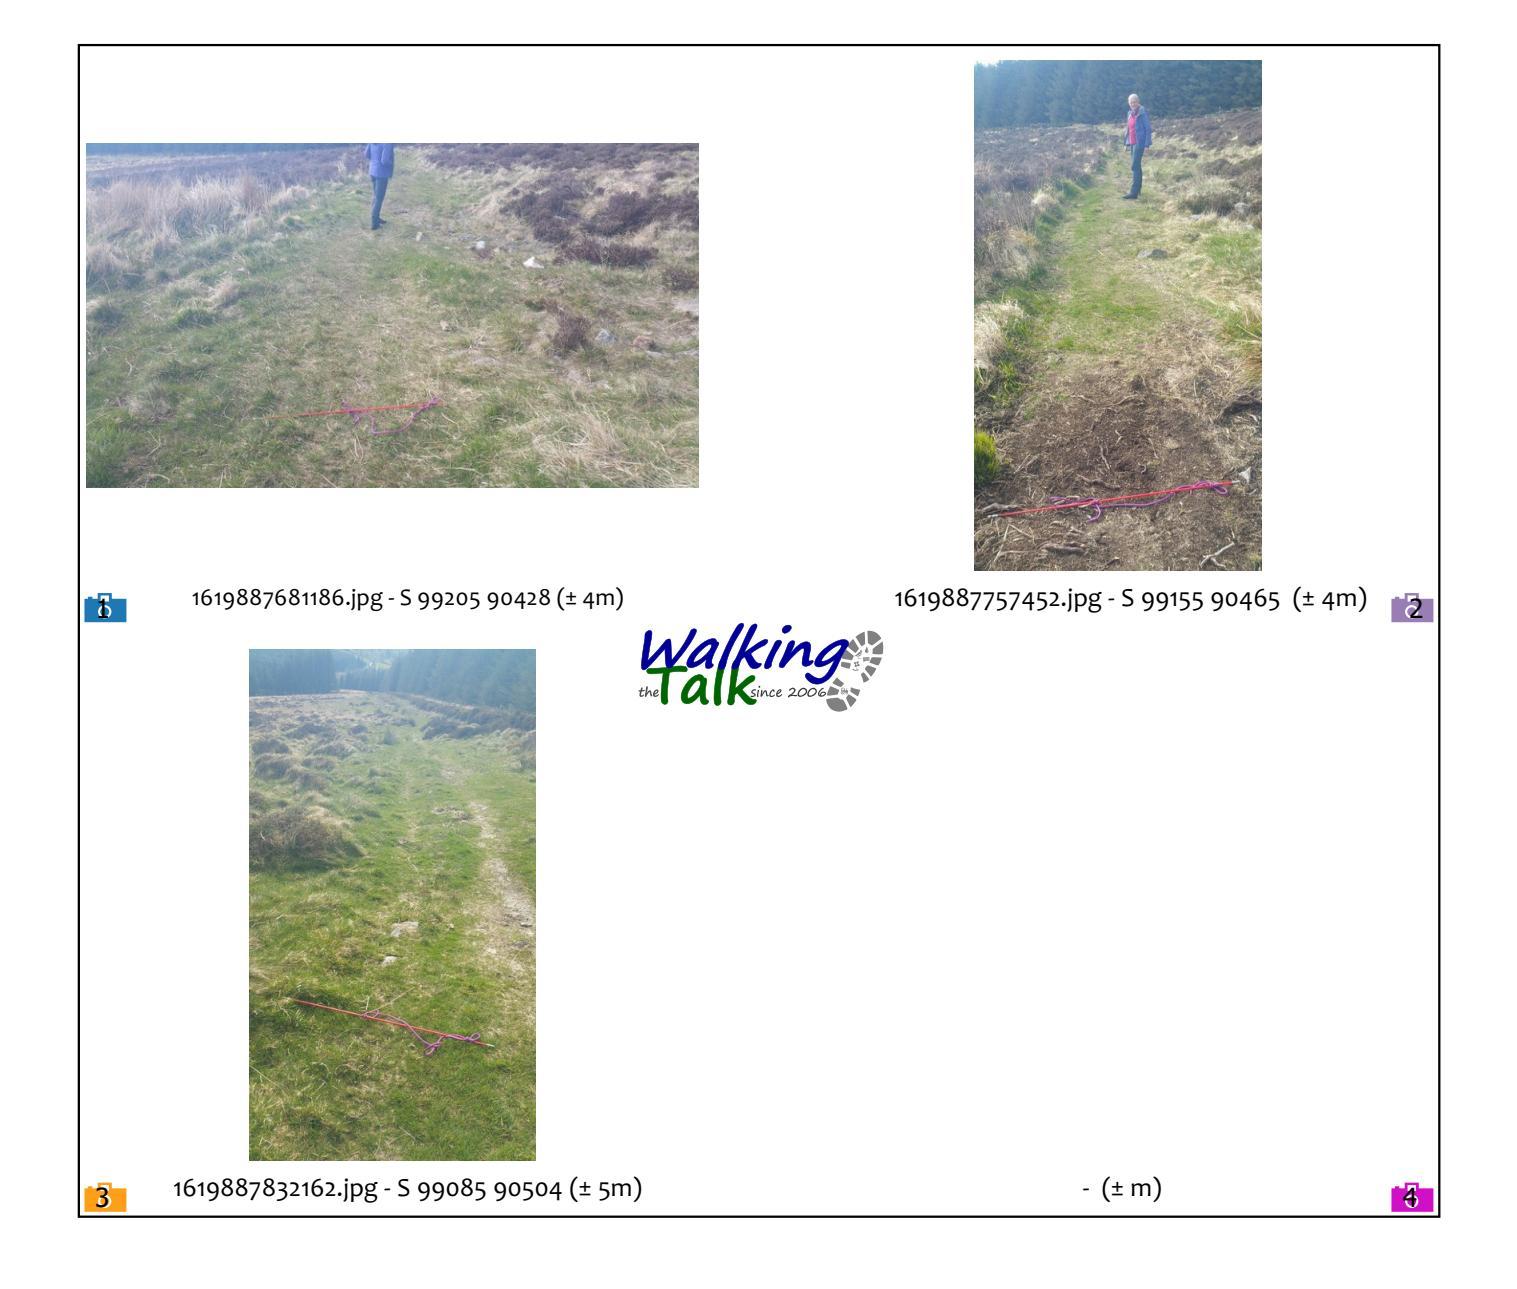
Substrate		Peat Depth ((cm)	Availability of Materials:
mineral_soil		0		
				Site Assessment: Close to road and accessible
	Minimum	Maximum	Typical	
Trampled width (m)	1.5	1.5	2	
Bare width (m)	0	0	1.5	
Eroded depth (m)	0	0	0.2

Work type	Estimated input	Work Summary
none		Used by off road vehicles (possibly for land management) so no work is viable

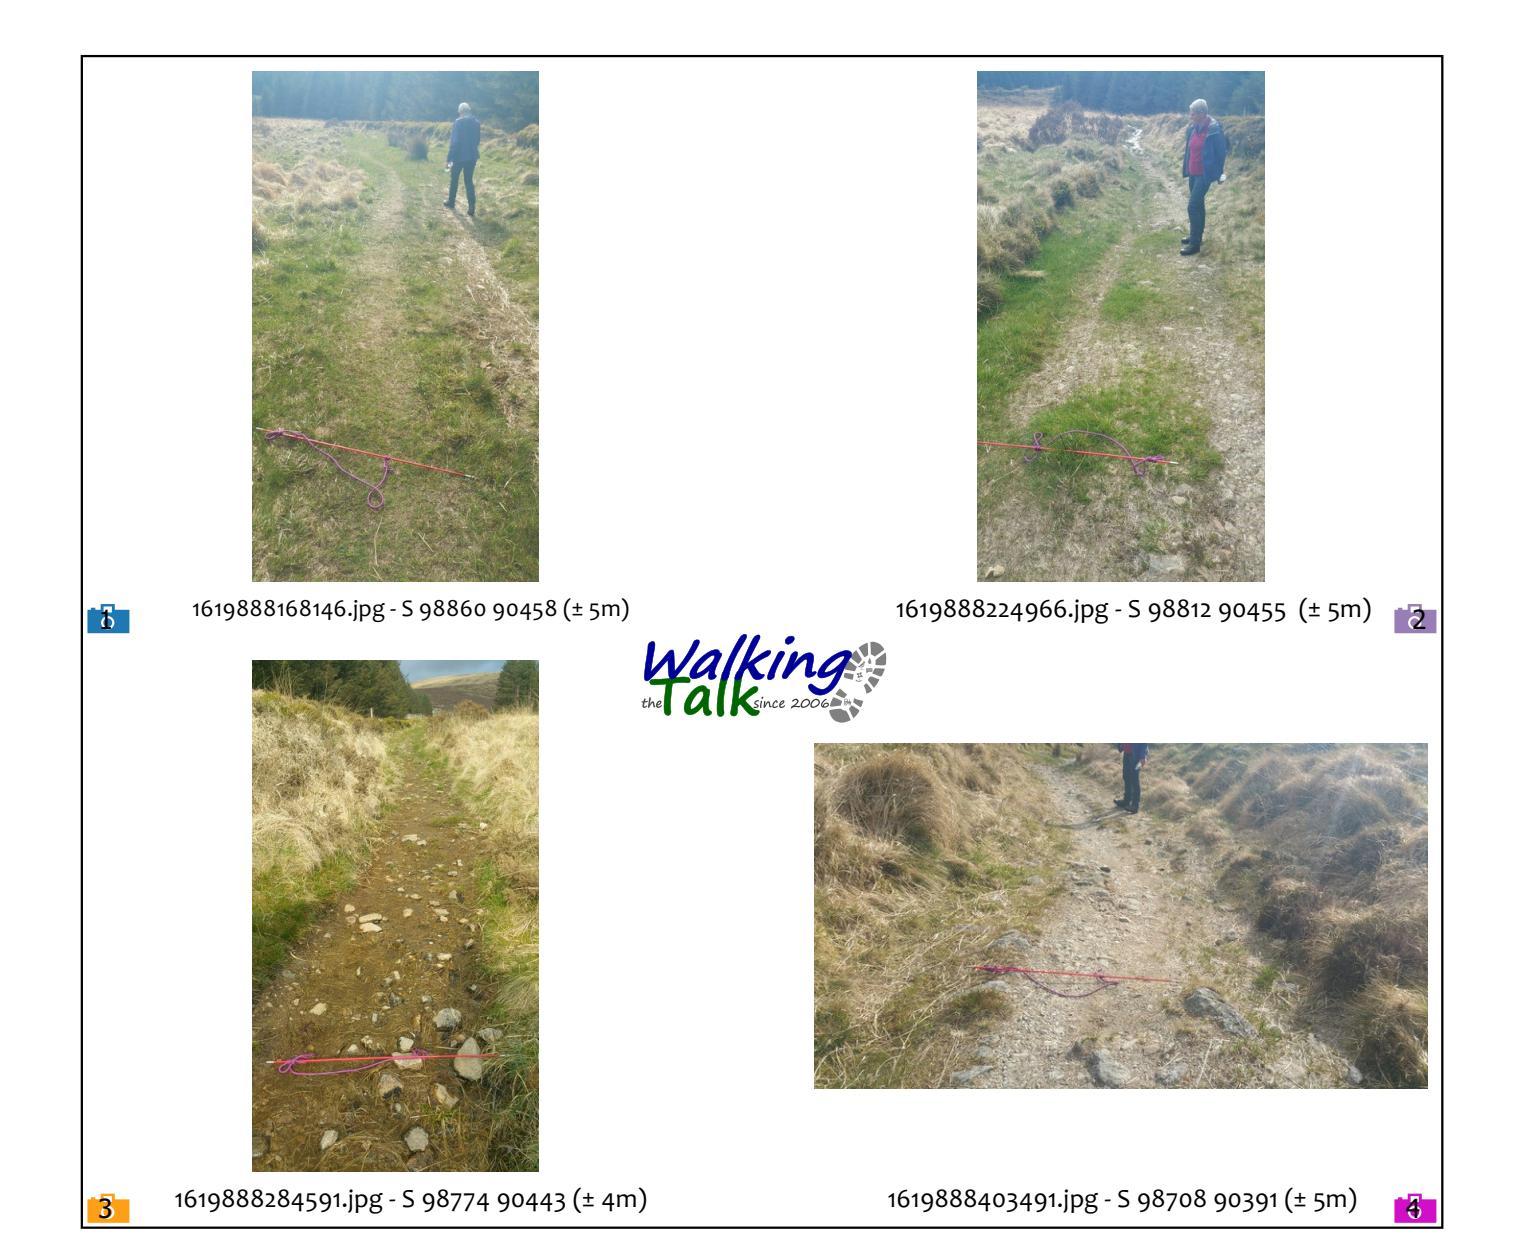
Substrate		Peat Depth (cm)		Availability of Materials: No block stone visible -
mineral_soil		0		aggregate may be accessible in borrow pit if
				required
	Minimum	Maximum	Typical	
Trampled width (m)	0	0	0	Site Assessment: Close to road and easily
Bare width (m)	0	0	1.5	accessible
Eroded depth (m)	0	0	0

Work type	Estimated input	Work Summary
early_intervention	5 days labour	Although the route is used by vehicles minor drainage would be advantageous to deflect and keep surface water off the track
